**Flood Control Project Maintenance
Levee Inspections****LMA District Cover Sheet****Spring 2014 Levee Inspection Results****Levee District No. 0002 (Glenn County)**

Spring 2014 Levee Inspection Results

Levee District No. 0002 (Glenn County)

Waterway			Bank	Unit Miles
Unit No. 01 Glenn County Sacramento River			Right	4.89
	Spring (March - May)	Summer (June - August)	(September - November) Fall	Winter (December - February)
Unit Maintenance Rating (Fall Only)				
Date of Inspection	03/18/2014 - 03/18/2014			
DWR Inspector	Bob Duffey			
Accompanied By	Dennis Clark

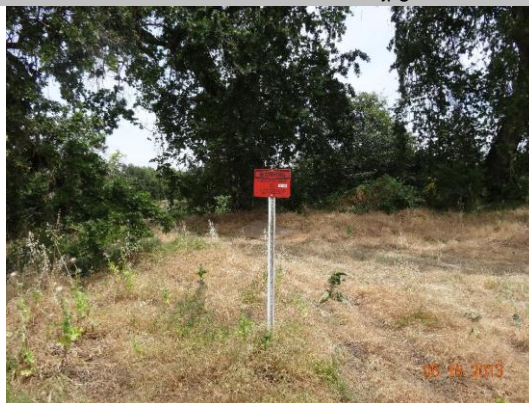
Photo 1 of 1 : UCIP_1637.jpg

LM Start	0.00	Rating **	M	Issue No.	10
LM End	0.00	Issue Type +	En	Location *	LS
Category	Supplemental			GPS Latitude/Longitude	
				Start	End
Item	DWR UCIP Field Study			39.414312 °	39.414312 °
				-122.010042 °	-122.010042 °
DWR ID	DWR_LD0002_01_s _ 2014_10				
Action/Comments					
Inspector Comments: FS_ID:18014					
EP_NO: 17124					
Repair Type:					
Crossing Status:					
UCIP Comments: Marker found on WS 15' from toe.					
FIELD_STRUCT_DESC: 10-inch steel conduit extending along the					
landside toe. Conduit contains twelve 1.25-inch HDPE ducts with fiber					
optic cables.					
FS Date: 5/16/2013

Indicator found on WS.

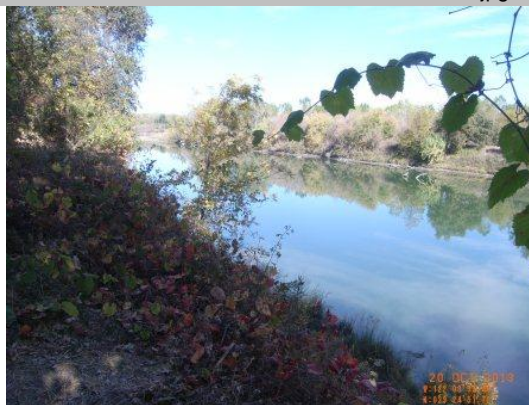
Photo 1 of 2 : USACE2013A_SAC_164-7_R_1.jpg

LM Start	0.02	Rating **	M	Issue No.	6
LM End	0.02	Issue Type +	Ma	Location *	WS
Category	Supplemental			GPS Latitude/Longitude	
				Start	End
Item	USACE Erosion Survey			39.414649 °	39.417689 °
				-122.009853 °	-122.010369 °
DWR ID					
Action/Comments					
Inspector Comments: 2009 - Very slow retreat, hard toe, encroaching into the levee projection. 2010 - Slowly eroding. 2011 - Site extended downstream. 2013: No observed changes. [2013 Site ID: SAC_164-7_R]

USACE 2013 Photo #1

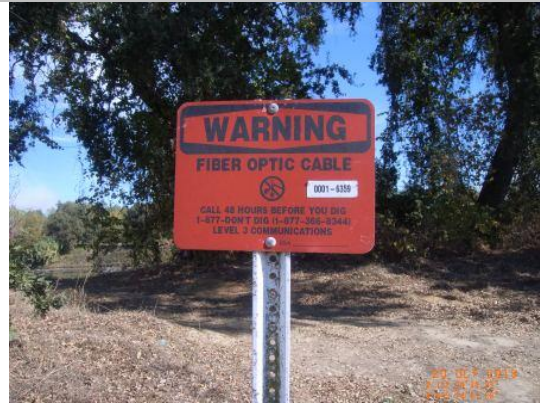
Photo 2 of 2 : USACE2013A_SAC_164-7_R_3.jpg

LM Start	0.02	Rating **	M	Issue No.	6 (cont)
LM End	0.02	Issue Type +	Ma	Location *	WS
Category	Supplemental			GPS Latitude/Longitude	
				Start	End
Item	USACE Erosion Survey			39.414649 °	39.417689 °
				-122.009853 °	-122.010369 °
DWR ID					
Action/Comments					
Inspector Comments: 2009 - Very slow retreat, hard toe, encroaching into the levee projection. 2010 - Slowly eroding. 2011 - Site extended downstream. 2013: No observed changes. [2013 Site ID: SAC_164-7_R]

USACE 2013 Photo #2

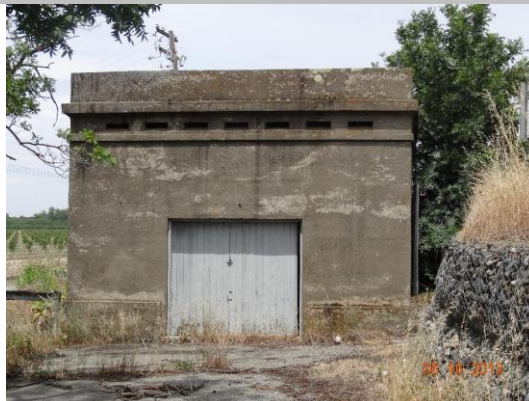
Photo 1 of 1 : UCIP_2082.jpg

LM Start	0.62	Rating **	M	Issue No.	20
LM End	0.62	Issue Type +	En	Location *	WS
Category	Supplemental			GPS Latitude/Longitude	
				Start	End
Item	DWR UCIP Field Study			39.422314 °	39.422314 °
				-122.011803 °	-122.011803 °
DWR ID	DWR_LD0002_01_s _ 2014_20

Action/Comments					
Inspector Comments: FS_ID:19705					
EP_NO: N/A					
Repair Type:					
Crossing Status:					
UCIP Comments: 3 pipes found in the pump house. Pump house does not appear to be in use. Unable to locate pipes on the waterward side. Will need to coordinate with owner and CVFPB regarding proper removal per Title 23 requirements.					
FIELD_STRUCT_DESC: [Princeton-Cordora-Glenn Irrigation District: Schaad Pumping Plant] 2 of 3: 34-inch steel pipe sleeved through 36-inch steel pipe through the levee, 20.0 feet below the crown. Annular gap is grouted. Flap gate on landward end. Pump in pump house on landward slope. Rock revetment around outlet on waterward slope. (USACE-1955). This entry matches the Drainage or Irrigation Structure referenced in O&M manual (Station 41+47). Pipes sleeved through pre-existing pipes, pump and parallel 28-inch pipe installed.					
FS Date: 5/16/2013

View of Princeton-Cordora-Glenn Irrigation District--Schaad Pumping Plant.

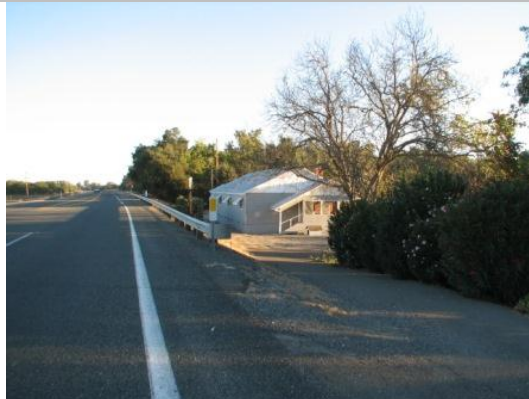
Photo 1 of 1 : rduffey_s_20140304_245.jpg

LM Start	1.04	Rating **	M	Issue No.	8
LM End	1.04	Issue Type +	En	Location *	WS
Category	Earthen Levee			GPS Latitude/Longitude	
				Start	End
Item	Encroachments			39.428322 °	39.428322 °
				-122.010973 °	-122.010973 °
DWR ID	DWR_LD0002_01_s_2012_8				
Action/Comments					
Building

View of house along w/s toe.

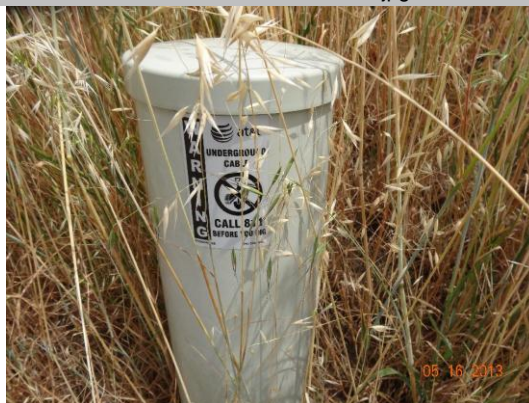
Photo 1 of 1 : UCIP_1641.jpg

LM Start	1.06	Rating **	M	Issue No.	24
LM End	1.06	Issue Type +	En	Location *	WS
Category	Supplemental			GPS Latitude/Longitude	
				Start	End
Item	DWR UCIP Field Study			39.428584 °	39.428584 °
				-122.011021 °	-122.011021 °
DWR ID	DWR_LD0002_01_s _ 2014_24				
Action/Comments					
Inspector Comments: FS_ID:18016					
EP_NO: 9723					
Repair Type:					
Crossing Status:					
UCIP Comments: Boxes on LS toe 2 splice.					
FIELD_STRUCT_DESC: Buried telephone cable through the levee.					
This line was retained under ABO No. 9723 (1974). Provide a field description of this crossing.					
FS Date: 5/16/2013

Indicator box found on LS toe.

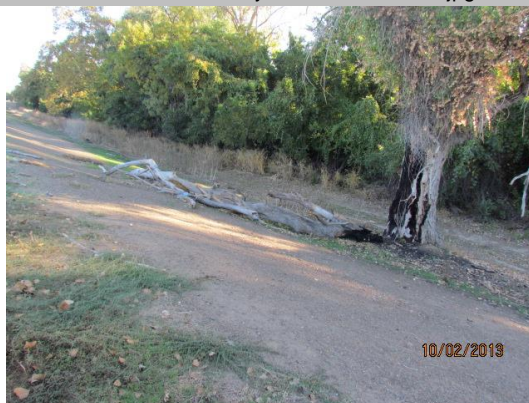
Photo 1 of 1 : rduffey_s_20140304_251.jpg

LM Start	1.26	Rating **	M	Issue No.	40
LM End	1.26	Issue Type +	En	Location *	WS
Category	Earthen Levee			GPS Latitude/Longitude	
				Start	End
Item	Encroachments			39.431499 °	39.431499 °
				-122.010803 °	-122.010803 °
DWR ID	DWR_LD0002_01_f_2013_40				
Action/Comments					
Tree or limb

View of the downed tree limb along the slope of the levee.

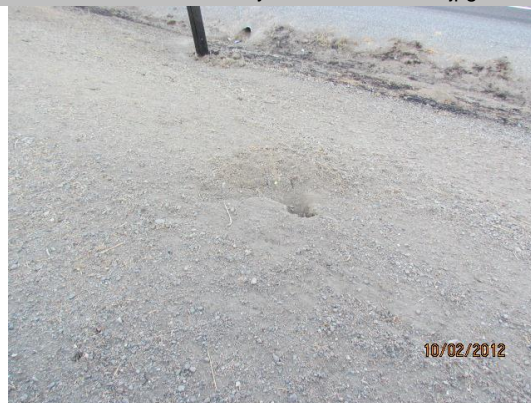
Photo 1 of 1 : rduffey_s_20140304_240.jpg

LM Start	1.45	Rating **	M	Issue No.	4
LM End	1.45	Issue Type +	Ma	Location *	LS
Category	Earthen Levee			GPS Latitude/Longitude	
				Start	End
Item	Animal Control			39.434157 °	39.434157 °
				-122.010760 °	-122.010760 °
DWR ID	DWR_LD0002_01_f_2012_4				
Action/Comments					
No rodents visible, but rodent burrows visible; need to backfill and compact or grout burrows.

View of the rodent holes along the landside slope.

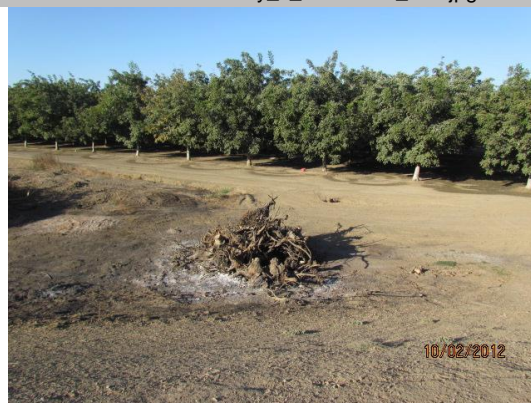
Photo 1 of 1 : rduffey_s_20140304_250.jpg

LM Start	1.54	Rating **	M	Issue No.	15
LM End	1.62	Issue Type +	Ma	Location *	LS
Category	Earthen Levee			GPS Latitude/Longitude	
				Start	End
Item	Animal Control			39.435485 °	39.436643 °
				-122.010640 °	-122.010498 °
DWR ID	DWR_LD0002_01_f_2012_15				
Action/Comments					
No rodents visible, but rodent burrows visible; need to backfill and compact or grout burrows.

View of the rodent holes along the landside slope.

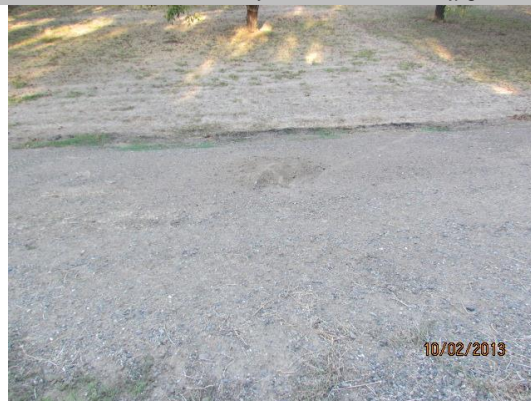
Photo 1 of 1 : rduffey_s_20140304_252.jpg

LM Start	1.58	Rating **	A/W	Issue No.	41
LM End	1.58	Issue Type +	Ma	Location *	LS
Category	Earthen Levee			GPS Latitude/Longitude	
				Start	End
Item	Animal Control			39.436149 °	39.436149 °
				-122.010525 °	-122.010525 °
DWR ID	DWR_LD0002_01_f_2013_41				
Action/Comments					
No rodents visible, but rodent burrows visible; need to backfill and compact or grout burrows.

View of the rodent holes along the slope of the levee.

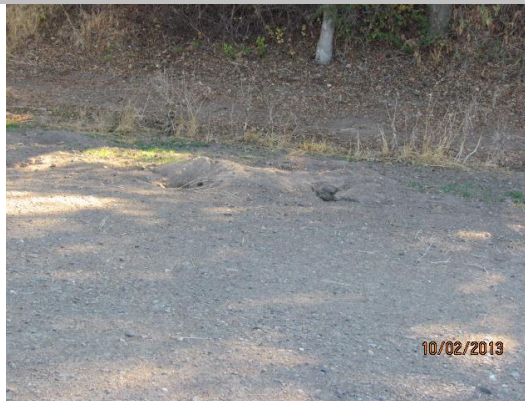
Photo 1 of 1 : rduffey_s_20140304_253.jpg

LM Start	2.81	Rating **	A/W	Issue No.	42
LM End	2.81	Issue Type +	Ma	Location *	WS
Category	Earthen Levee			GPS Latitude/Longitude	
				Start	End
Item	Animal Control			39.451841 °	39.451841 °
				-122.017120 °	-122.017120 °
DWR ID	DWR_LD0002_01_f_2013_42				
Action/Comments					
No rodents visible, but rodent burrows visible; need to backfill and compact or grout burrows.

View of the rodent holes along the slope of the levee.

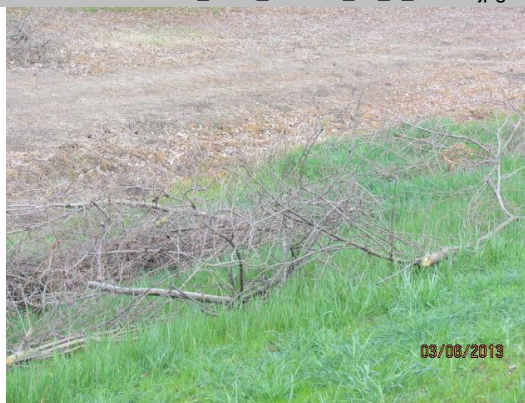
Photo 1 of 1 : SP_2014_LD0002_28_5_06158.jpg

LM Start	2.93	Rating **	M	Issue No.	5
LM End	2.93	Issue Type +	En	Location *	LS
Category	Earthen Levee			GPS Latitude/Longitude	
				Start	End
Item	Encroachments			39.453490 °	39.453490 °
				-122.016457 °	-122.016457 °
DWR ID	DWR_LD0002_01_s_2013_5				
Action/Comments					
Prunings

View of the prunings along the landside toe.

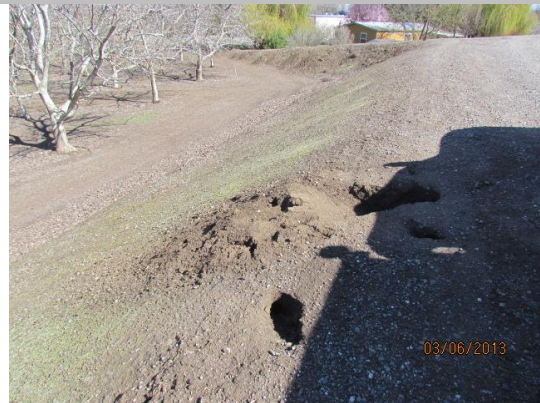
Photo 1 of 1 : rduffey_s_20140304_248.jpg

LM Start	3.20	Rating **	M	Issue No.	12
LM End	3.20	Issue Type +	Ma	Location *	WS
Category	Earthen Levee			GPS Latitude/Longitude	
				Start	End
Item	Animal Control			39.455992 °	39.455992 °
				-122.012809 °	-122.012809 °
DWR ID	DWR_LD0002_01_s _ 2013_12				
Action/Comments					
Exterminate rodents and backfill and compact or grout burrows.

View of the rodent activity along the landside slope.

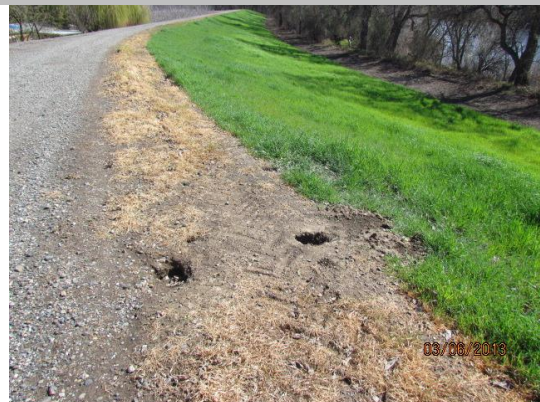
Photo 1 of 1 : SP_2014_LD0002_28_9_06157.jpg

LM Start	3.20	Rating **	M	Issue No.	9
LM End	3.20	Issue Type +	Ma	Location *	LS
Category	Earthen Levee			GPS Latitude/Longitude	
				Start	End
Item	Animal Control			39.455992 °	39.455992 °
				-122.012808 °	-122.012808 °
DWR ID	DWR_LD0002_01_s _ 2013_9				
Action/Comments					
No rodents visible, but rodent burrows visible; need to backfill and compact or grout burrows.

View of the rodent activity along the waterside slope.

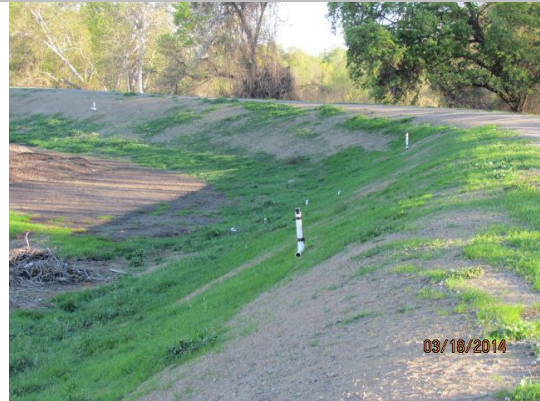
Photo 1 of 1 : rduffey_s_20140407_151.jpg

LM Start	3.48	Rating **	A/W	Issue No.	27
LM End	3.56	Issue Type +	Ma	Location *	LS
Category	Earthen Levee			GPS Latitude/Longitude	
				Start	End
Item	Animal Control			39.457692 °	39.458705 °
				-122.009517 °	-122.009872 °
DWR ID	DWR_LD0002_01_s _ 2014_27				
Action/Comments					
No rodents visible, but rodent burrows visible; need to backfill and compact or grout burrows.

View of the rodent activity along the l/s slope.

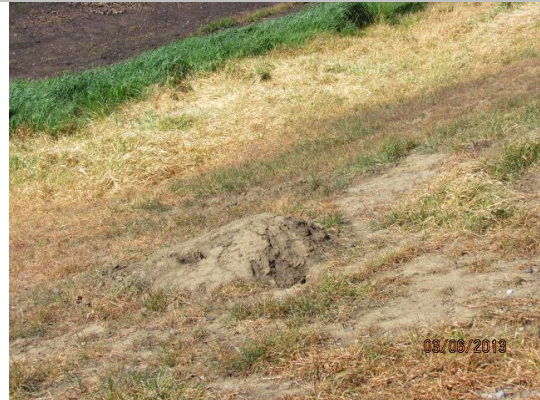
Photo 1 of 1 : rduffey_s_20140304_249.jpg

LM Start	3.56	Rating **	M	Issue No.	13
LM End	3.61	Issue Type +	Ma	Location *	LS
Category	Earthen Levee			GPS Latitude/Longitude	
				Start	End
Item	Animal Control			39.458803 °	39.459305 °
				-122.009980 °	-122.010511 °
DWR ID	DWR_LD0002_01_s _ 2013_13				
Action/Comments					
Exterminate rodents and backfill and compact or grout burrows.

View of the rodent activity along the landside slope.

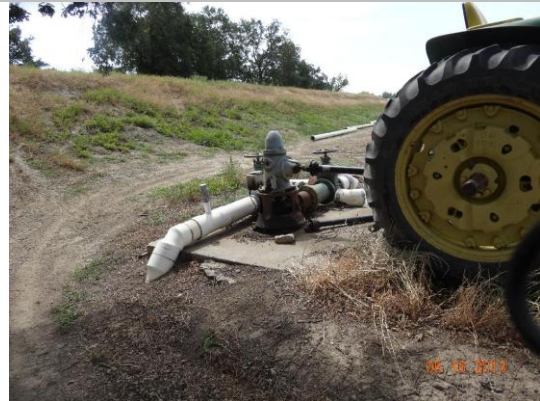
Photo 1 of 1 : UCIP_2110.jpg

LM Start	3.70	Rating **	M	Issue No.	25
LM End	3.70	Issue Type +	En	Location *	LS
Category	Supplemental			GPS Latitude/Longitude	
				Start	End
Item	DWR UCIP Field Study			39.461509 °	39.461509 °
				-122.011218 °	-122.011218 °
DWR ID	DWR_LD0002_01_s _ 2014_25				
Action/Comments					
Inspector Comments: FS_ID:19745					
EP_NO: 16931					
Repair Type:					
Crossing Status:					
UCIP Comments: Inspector notes indicate that pipe was never installed through levee and application was closed. Steel pipe was not installed but detachable section was installed. The pipe section goes up and over levee. Permit 16931 file was closed in 2005 owner was unable to install pipe due to costs. Permit indicates that pipe was to be used for winter supply of irrigation water to landward side. Need to coordinate with DWR inspector--permit revised for this type of structure?					
FIELD_STRUCT_DESC: Crossing visible at location. Current structure differs from original request in Permit No. 16931. PVC connection visible on landward toe with cutoff valve. Pipe connects to 8-inch PVC pipe extending past landward toe.

Pump system located near landward toe.

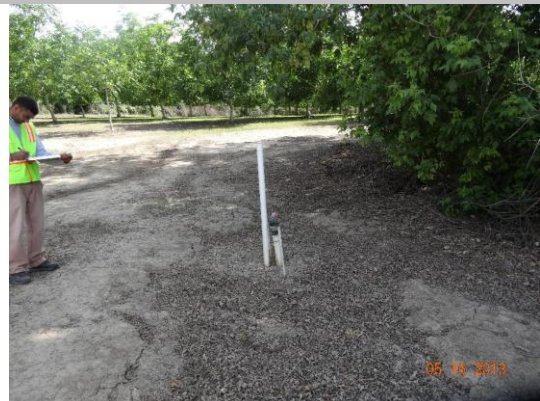
Photo 1 of 1 : UCIP_2073.jpg

LM Start	4.34	Rating **	M	Issue No.	26
LM End	4.34	Issue Type +	En	Location *	LS
Category	Supplemental			GPS Latitude/Longitude	
				Start	End
Item	DWR UCIP Field Study			39.469908 °	39.469908 °
				-122.012117 °	-122.012117 °
DWR ID	DWR_LD0002_01_s _ 2014_26				
Action/Comments					
Inspector Comments: FS_ID:19703					
EP_NO: 18072					
Repair Type:					
Crossing Status:					
UCIP Comments: Disturbed soil on the WS toe near the 3" PVC pipe.					
FIELD_STRUCT_DESC: 6-inch steel irrigation pipe through the levee, 2.0 feet below the levee. Provide a field description of this crossing.					
(Permit No. 18072-2006)					
FS Date: 5/16/2013

3-inch PVC pipe exposed on waterward toe.

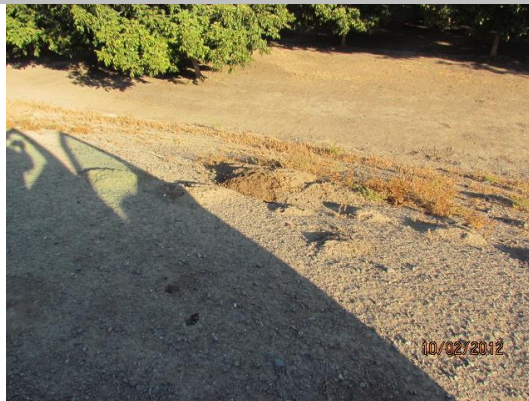
Photo 1 of 1 : rduffey_s_20140304_247.jpg

LM Start	4.87	Rating **	M	Issue No.	11
LM End	4.87	Issue Type +	Ma	Location *	LS
Category	Earthen Levee			GPS Latitude/Longitude	
				Start	End
Item	Animal Control			39.476676 °	39.476676 °
				-122.017439 °	-122.017439 °
DWR ID	DWR_LD0002_01_s _ 2012_11				
Action/Comments					
No rodents visible, but rodent burrows visible; need to backfill and compact or grout burrows.

View of the rodent holes along the levee slope.
